EVALUATION OF THE PERFORMANCE OF POLYURETHANE FOAMS IN RIGID
PAVEMENT PRESERVATION

A Thesis Submitted to the Faculty of the University of
Tennessee at Chattanooga in Partial
Fulfillment of the Requirements of the Degree
of Master of Engineering

The University of Tennessee at Chattanooga
Chattanooga, Tennessee

August 2018

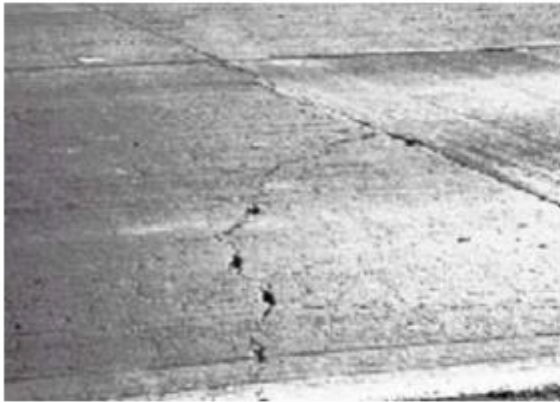
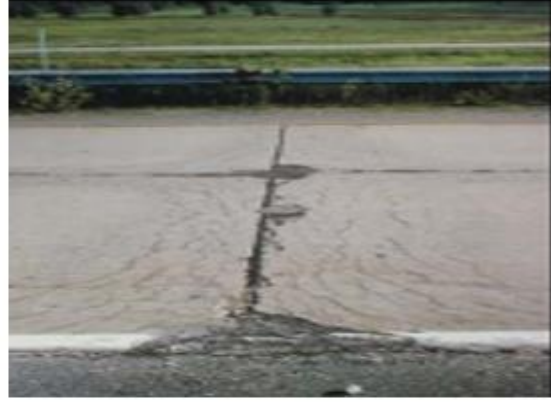
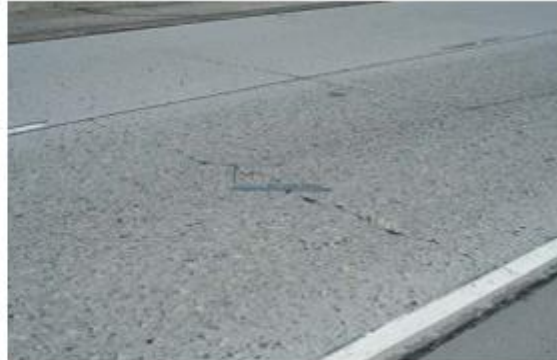
(a) Corner Cracking

(b) Durability "D" cracking

(c) Longitudinal cracking

(d) Transverse cracking

Figure 2.1 Types of cracking in rigid pavement (Source: Miller and Bellinger, 2014)

- i. Crackings in concrete pavements is a result of stresses caused by repeated traffic loading. These stresses may not even exceed the flexural strength of the concrete slab but still may lead to formation of structural cracks due to lack of uniform base support, among other things. Cracking is also influenced by weak subgrades, expansive soils, differential settlements and curling of concrete slabs due to temperature gradient (Bautista and Basheer, 2008). If not properly sealed cracks are likely to develop into concrete spalling in situation where there is erosion of subgrade/base support and crack formation as a result of moisture infiltration through cracks or joints (Bautista and Basheer, 2008). Figure 2.1 shows cracking distresses as categorized in the DIM-LTPP based on their location and formation on the pavement.

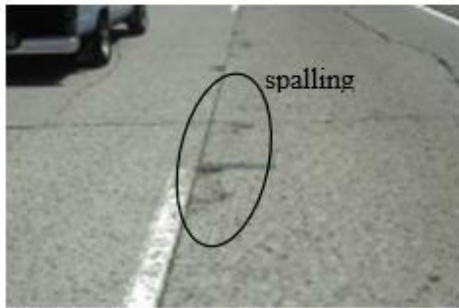
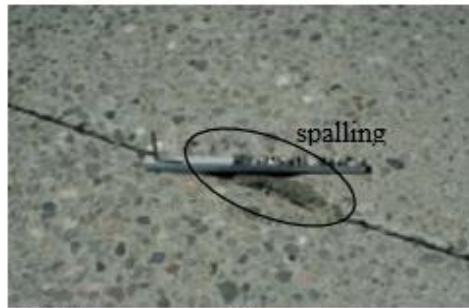
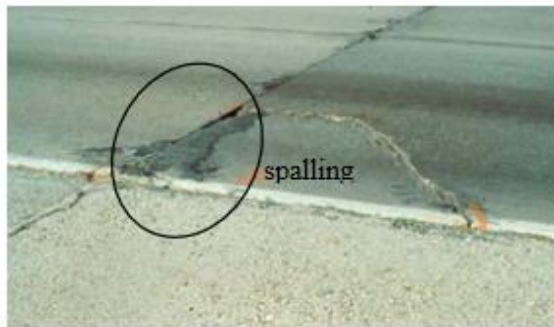
(a) Longitudinal spalling

(b) Transverse spalling

(c) Corner spalling

Figure 2.2 Slab spalling in rigid pavement (Source: Miller and Bellinger, 2014; North Carolina Department of Transportation, 2015)

- ii. Spalling of concrete pavement is identified by cracking, breaking, chipping or fraying of slab edge within 0.3 m from the face of longitudinal, transverse or corner of the pavement as shown in Figure 2.2 (Lee and Shields, 2010; Miller and Bellinger, 2014; North Carolina Department of Transportation, 2015).

Apart from being influenced by cracking near the transverse/longitudinal joints; according to Huang (2004) spalling (transverse or longitudinal) is also caused by poorly designed or constructed load transfer devices; corner spalling is caused by

freeze-thaw condition, durability cracking or other factors. Usually spalling extends to intersect the joint at an angle and not throughout the whole slab thickness (Huang, 2004). Spalling is a joint deficiency related distress, others include longitudinal and transverse joint seal damage.

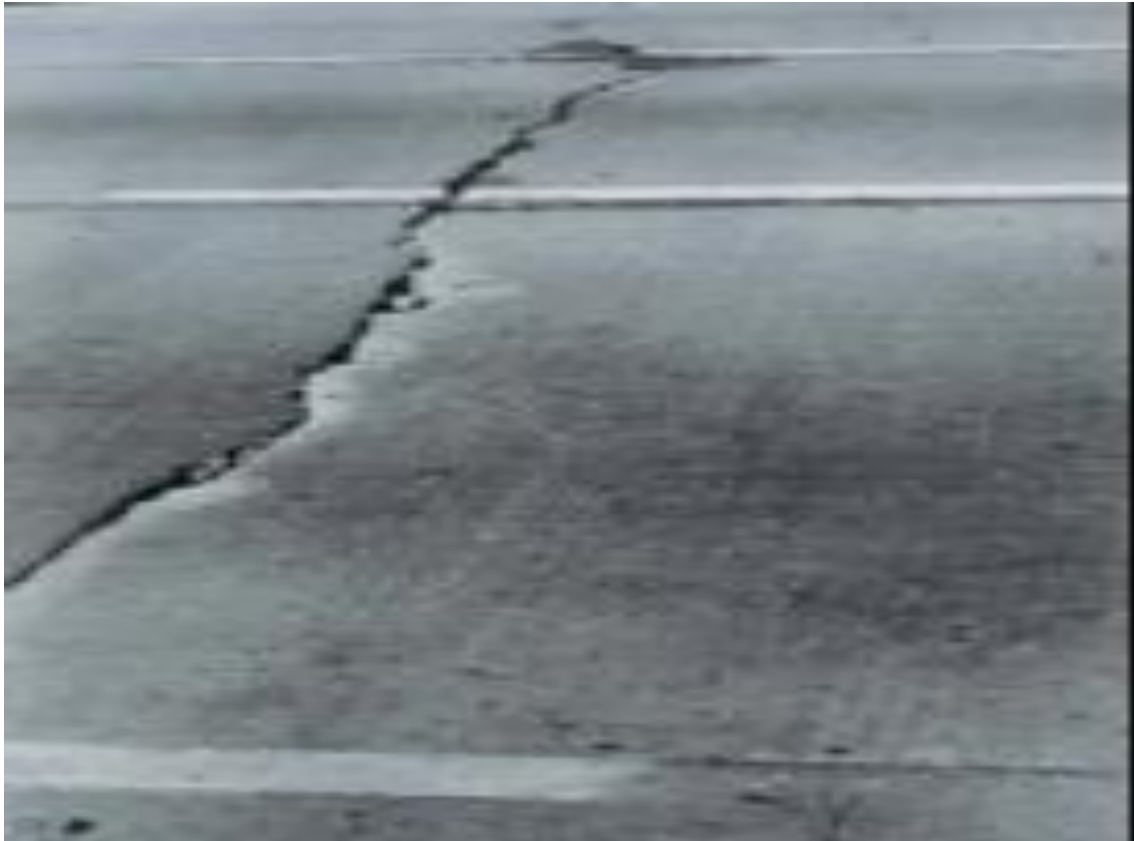
Figure 2.3 Faulting of transverse crack (Source: Miller and Bellinger (2014))

- iii. Faulting is commonly found in jointed concrete pavements without dowel bar reinforcement. It manifests as a slight settlement of the leading edge of each slab in the direction of traffic (Papagiannakis and Masad, 2017). Due to lack of dowel bars

or aggregate interlock in JPCP for load transfer, sudden increases in pore pressure in wet subgrades occur, which in turn produces migration of fines and settlement under the leading edge of each slab. Where the sudden pore pressure buildup is accompanied by squirting of water and fines through the joint, the distress is referred as pumping (Huang, 2004; Papagiannakis and Masad, 2017). Faulting can be either in the longitudinal or transverse direction of the joint or crack (Figure 2.3). However, the most common ones are near the joint in the transverse direction.

In most cases of faulting mechanism, the approach slab is higher than the leave (departure) slab and is considered as positive faulting; negative faulting is recorded when the leave slab is higher than the approach slab (Miller and Bellinger, 2014). Joint faulting is measured in the nearest mm (in.) at 0.3 m (1 ft) from the outside pavement edge and 0.75 m (2.50 ft) from the outside wheel path (Miller and Bellinger, 2014). Faulting leads to unevenness of the pavement affecting the roughness and ride quality on the pavement.

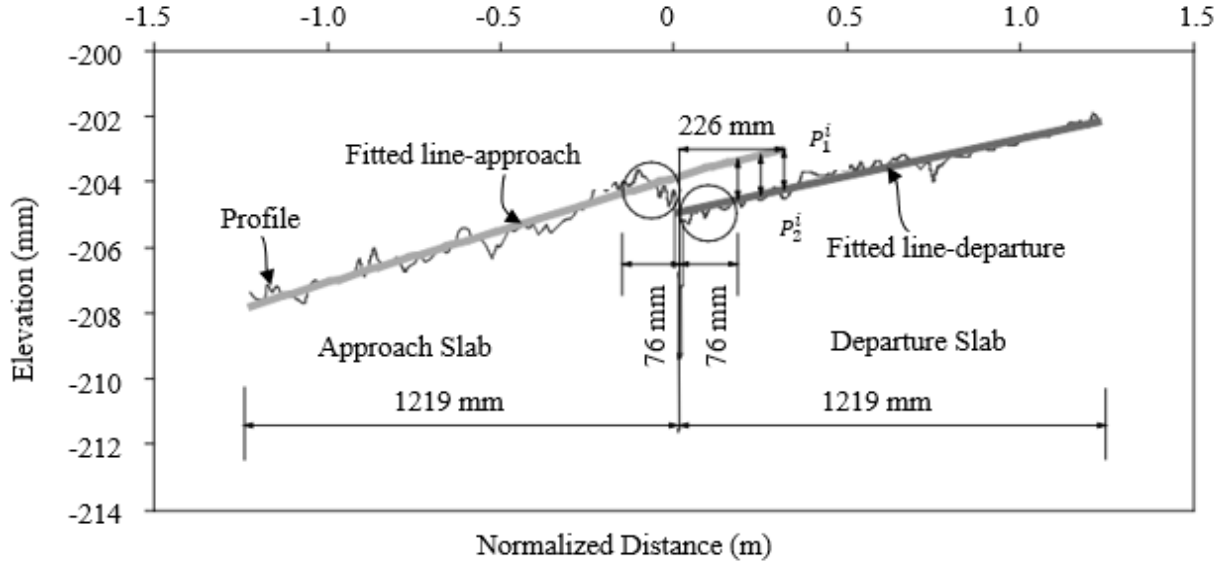
Figure 3.1 Cropped profile slices curve fitting and faulting computation (Source: Chang et al. [2012])

approach slab slice is recorded as P_1^i , and its corresponding elevation points from the departure slab slice as P_2^i .

- vi. The faulting value is computed by averaging the difference between the elevations data points (P_1^i and P_2^i) obtained in iv above.

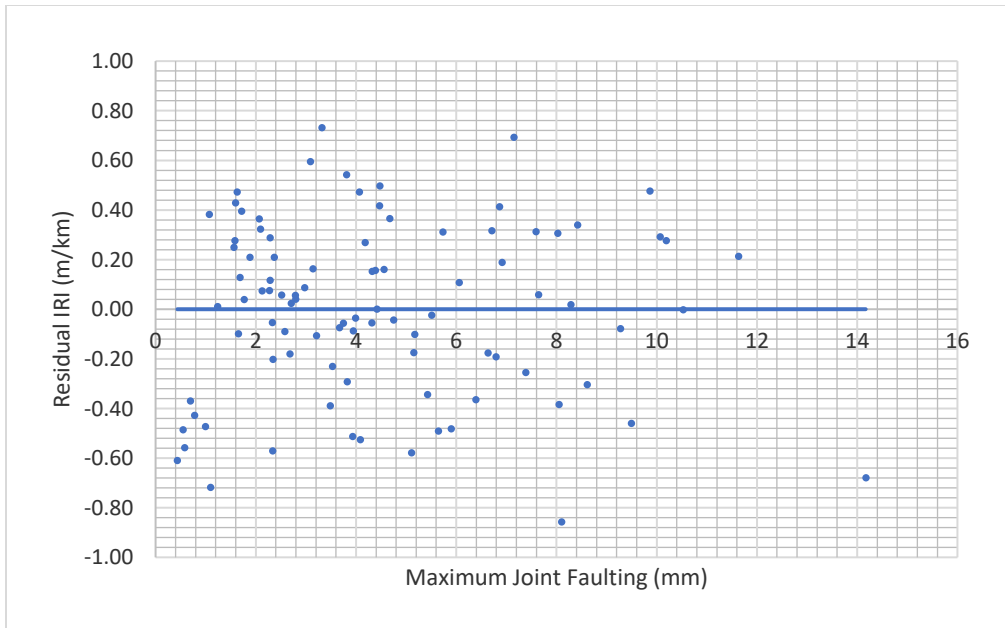
Figure 4.2 Residual IRI against maximum transverse joint faulting for left wheel truck

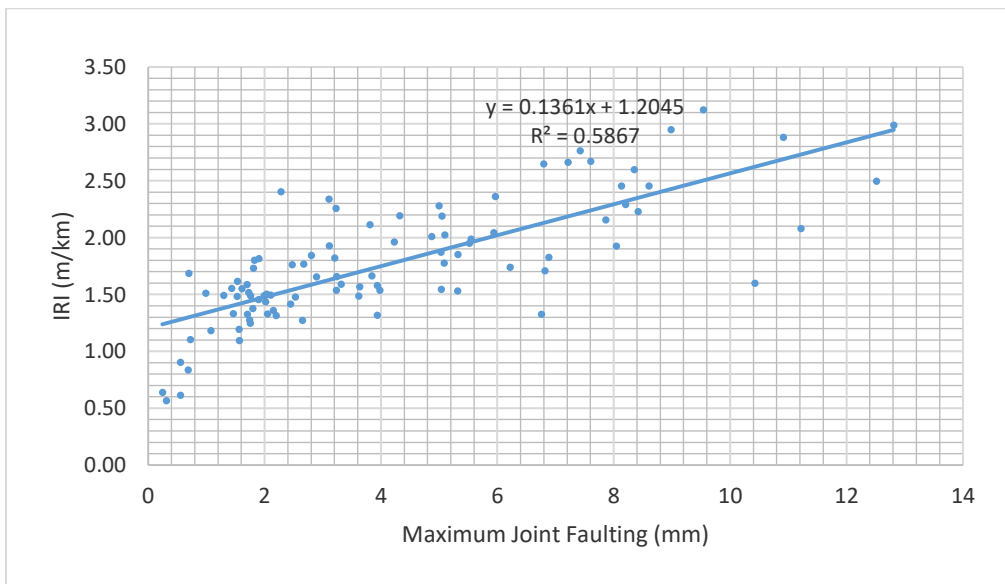
Figure 4.3 IRI against maximum transverse joint faulting for right wheel truck

Furthermore, maximum transverse joint faulting and mean IRI values in each 100 m segments from all the five sections were combined and correlated to obtain the relationship between the two indicators, for the left and right wheel track/path. Figure 4.1 and 4.3 show that

mean IRI increases with increase in maximum transverse joint faulting for both wheel paths. Positive y-intercepts (i.e., 1.0948 and 1.2045) indicates that IRI is affected partly with transverse joint faulting. Other distress such as spalling, and punchouts have an effect on IRI too. In general, R-squared values of 0.6639 and 0.5867 indicate that the simple linear regression model/equation fits the data well. Also, the residuals against the fitted value (transverse joint faulting) plots are approximately evenly spread and randomly distributed above and below 0, which further shows that the linear regression equation is a good fit of the data (Figure 4.2 and 4.4). The relation between the maximum joint faulting and IRI may be explained by using this simple linear equation.

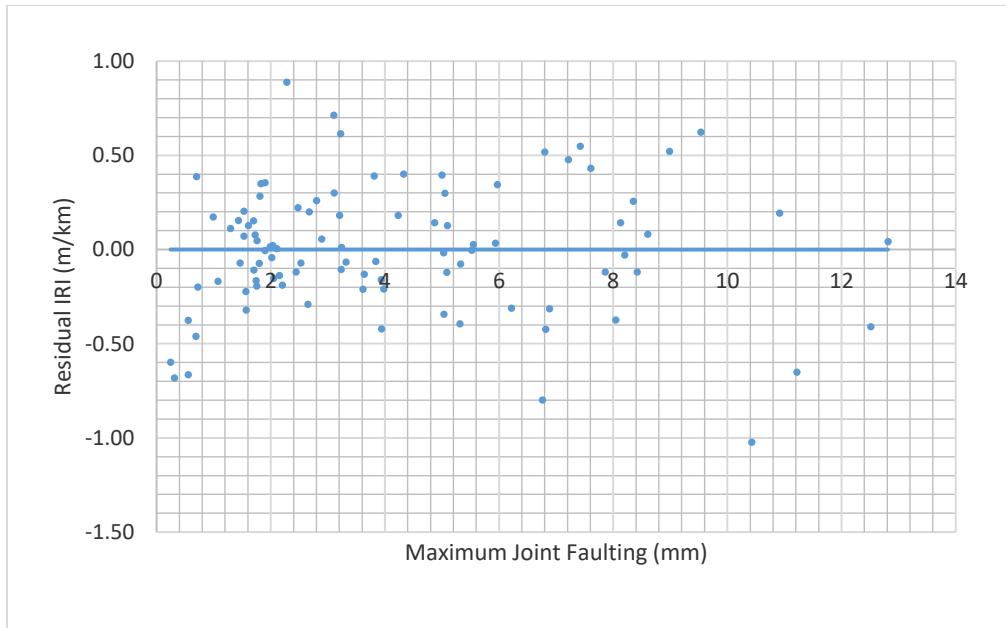
Figure 4.4 Residual IRI against maximum transverse joint faulting for right wheel truck

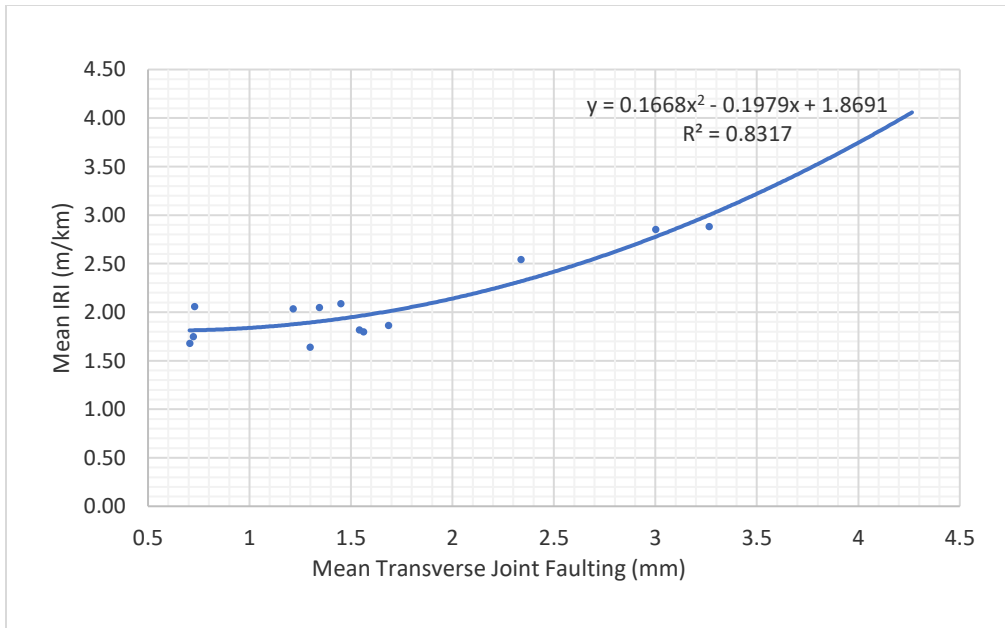
Figure 4.5 Mean IRI against mean transverse joint faulting

The overall absolute transverse joint faulting and mean IRI of the five sections in Tables 4.2 and 4.3 respectively were combined to obtain more samples for statistical correlation. The aggregated data is plotted as shown in Figure 4.5 to obtain the relationship between IRI and transverse joint faulting. It is observed that IRI increases with the increase of the mean transverse joint faulting, and they are polynomially related with a coefficient of determination of 0.83. The evenly distributed residuals above and below the zero line in Figure 4.6 further indicates that the model fits the data properly.

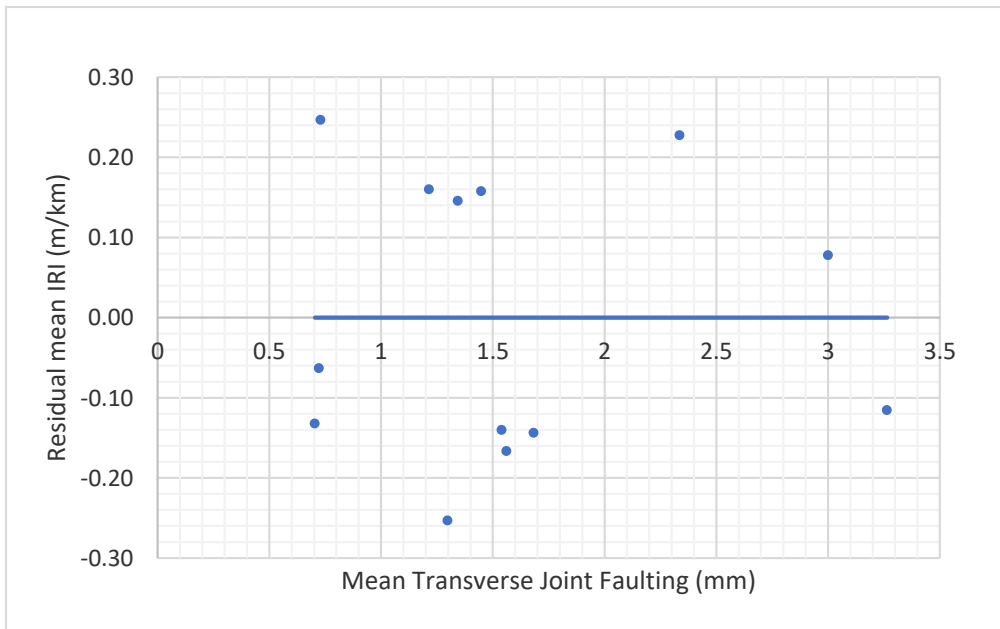
Figure 4.6 Residual mean IRI against mean transverse joint faulting

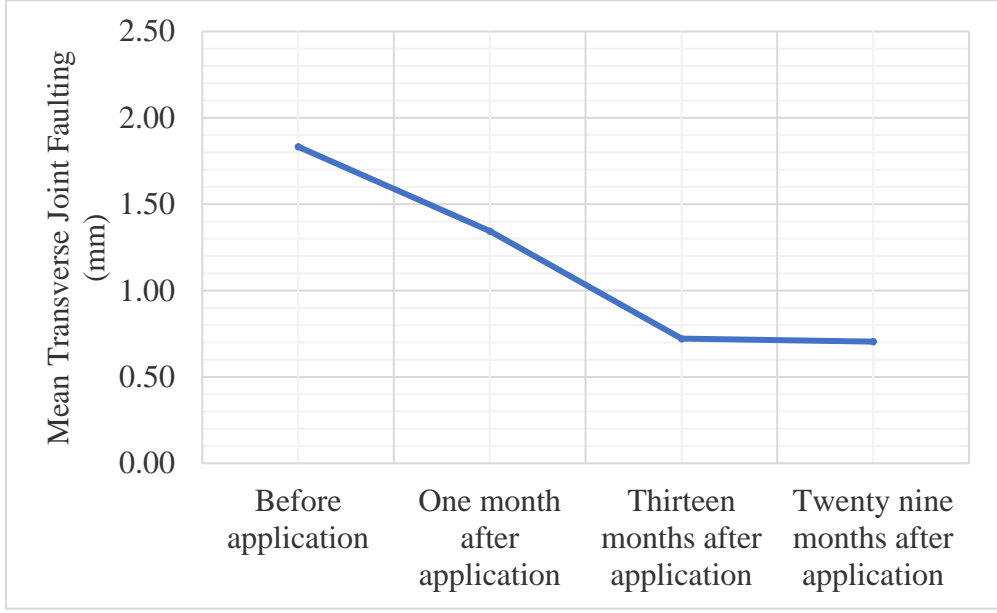
Figure A3 Variation of mean transverse joint faulting over time for section I-24 East_Moore

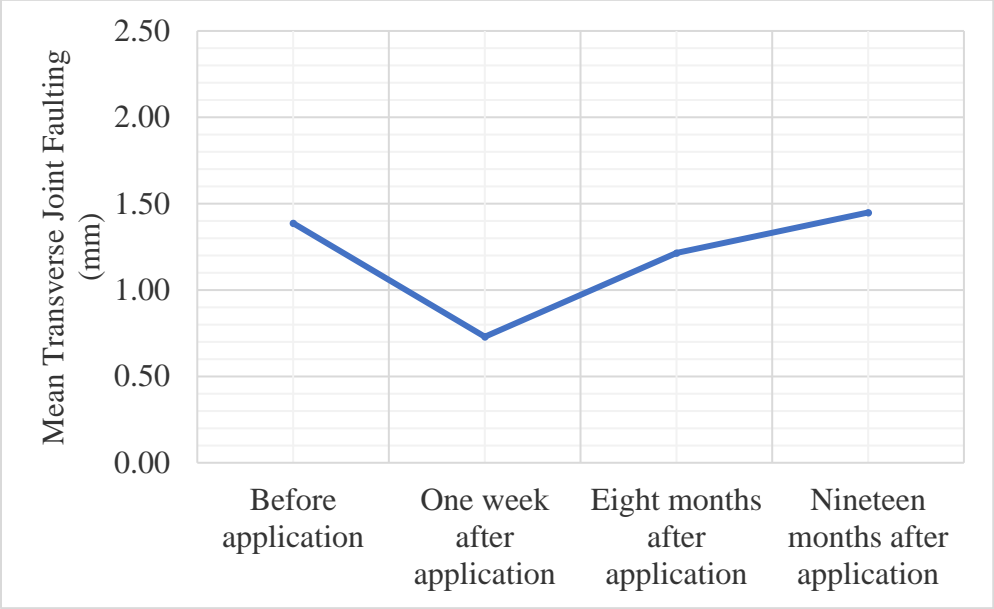
Figure A5 Variation of mean transverse joint faulting over time for section I-24 West
